Figure 1 Port Lands Study Area Environmental Assessment and Geotechnical and Earthworks Report *Waterfront Toronto Toronto, Ontario*

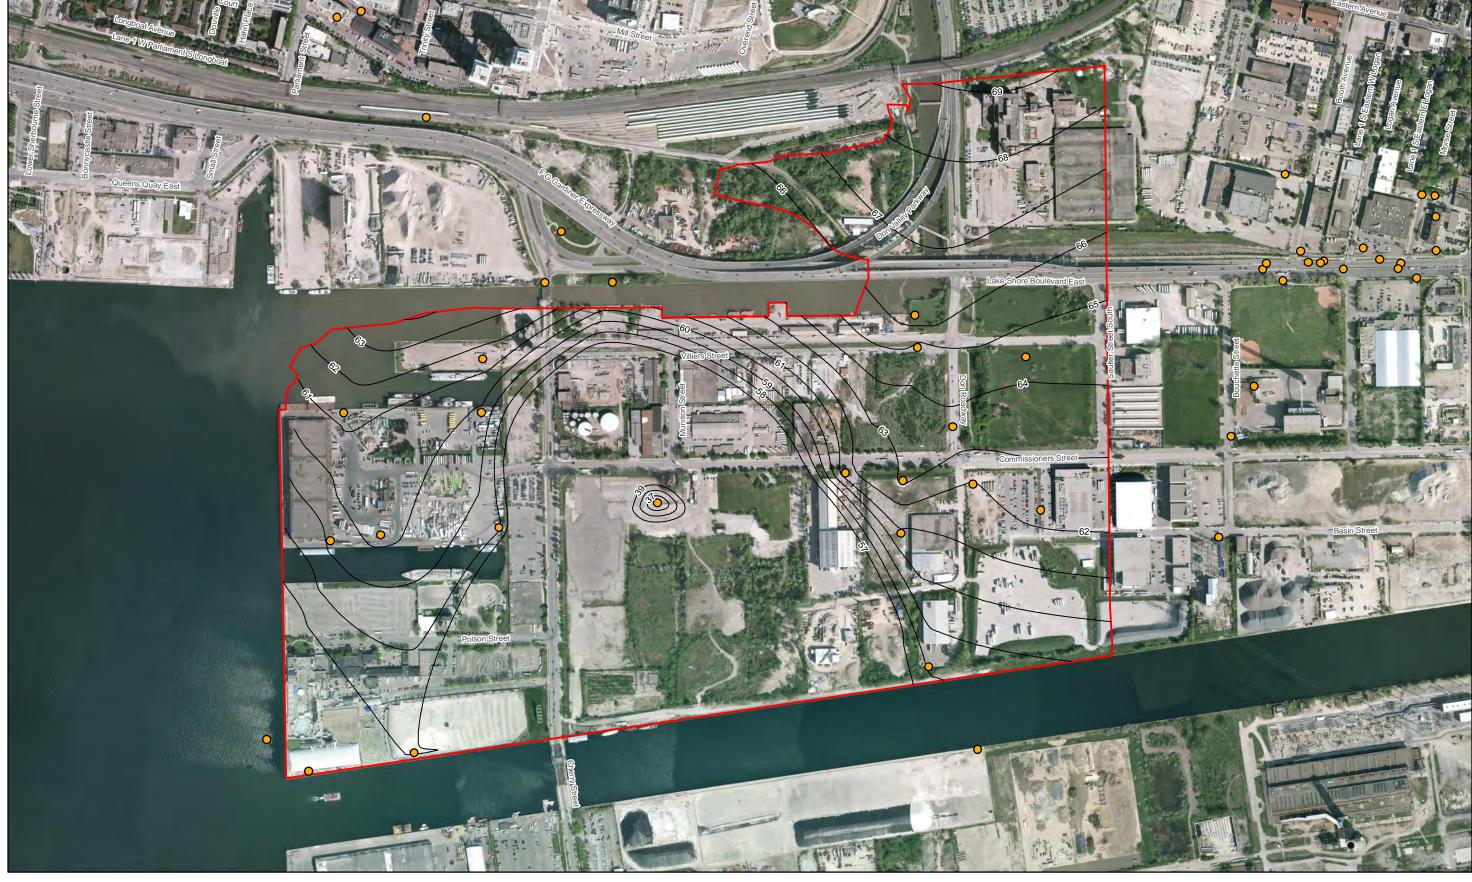
Figure 7 Bedrock Surface Elevation Environmental Assessment and Geotechnical and Earthworks Report *Waterfront Toronto Toronto, Ontario*

Stage 2 Study Boundary

Investigation Location with

Bedrock Elevation Information
Used in Bedrock Interpretation

___ Interpreted Top of Bedrock Elevation Contour

2. Elevations are in metres above sea level.

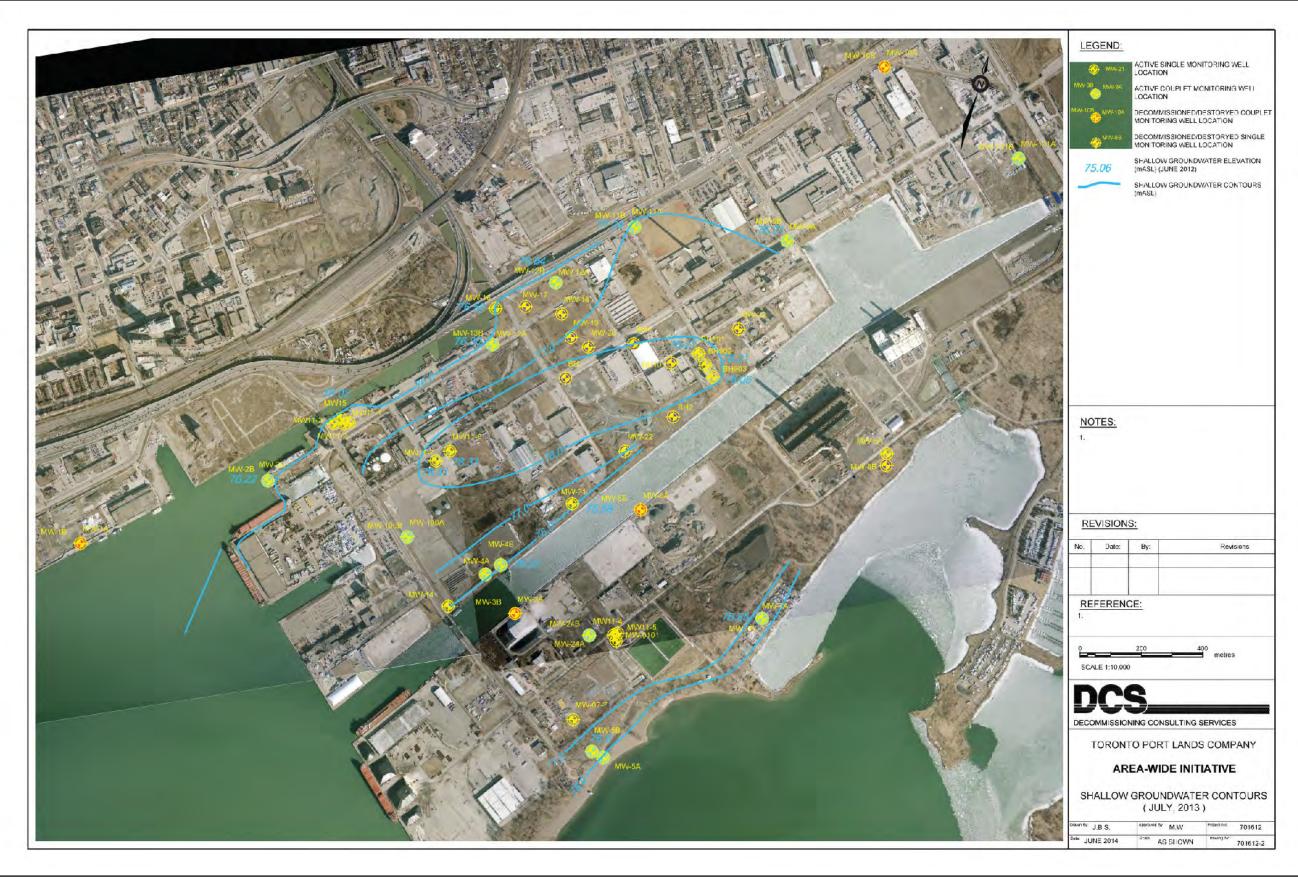
Figure 10C Groundwater Piezometric Contours – Fill / Native Sand, July, 2013 Environmental Assessment and Geotechnical and Earthworks Report Waterfront Toronto Toronto, Ontario

Notes:
1. Figure source: Decommissioning Consulting Services (DCS), July 2013.
Area-wide Initiative Groundwater Monitoring and Sampling Results - 2013

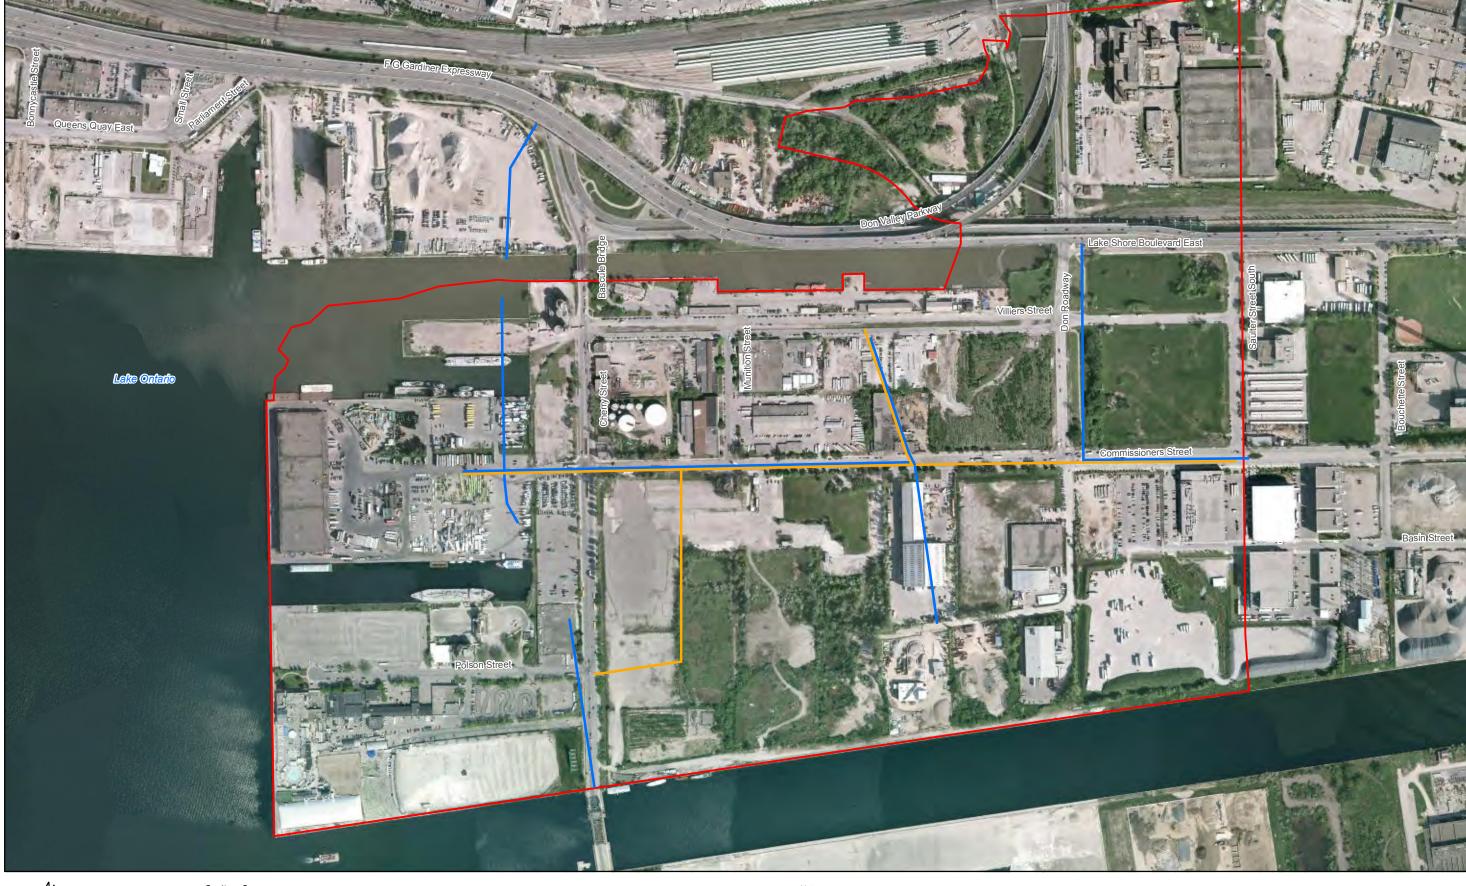
Figure 27
Subsurface Infrastructure Layout
Environmental Assessment and Geotechnical and Earthworks Report
Waterfront Toronto
Toronto, Ontario

0 20 40 60 80 Metres Sanitary SewerStorm SewerStage 2 Study Boundary

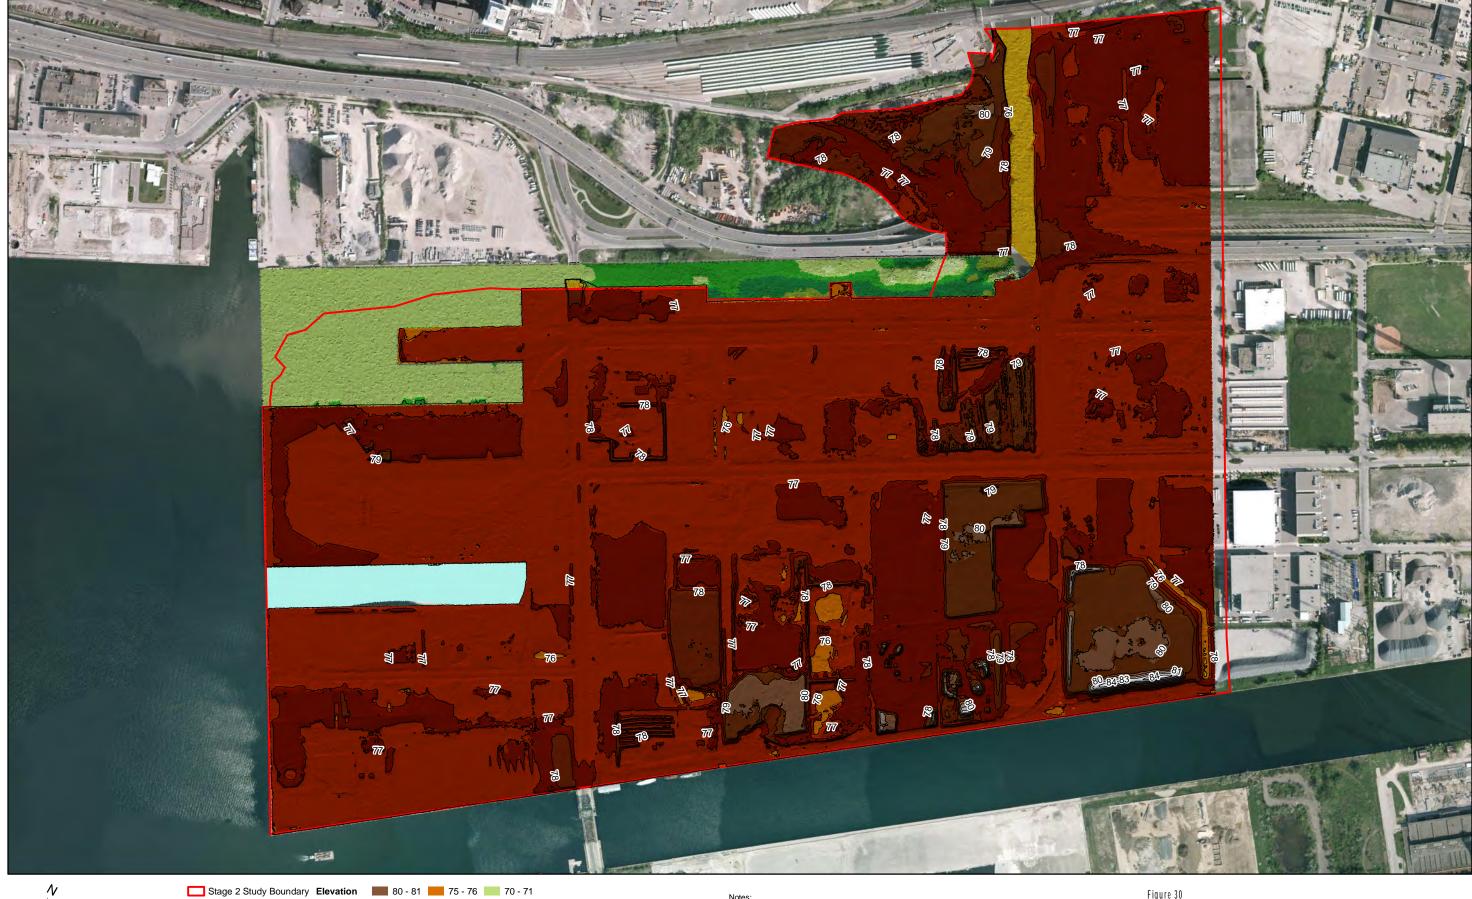
Figure 30 Existing Topography Environmental Assessment and Geotechnical and Earthworks Report *Waterfront Toronto Toronto, Ontario*

84 - 85 79 - 80 74 - 75 69 - 70 83 - 84 78 - 79 73 - 74 68 - 69 0 20 40 60 80 82 - 83 77 - 78 72 - 73 67 - 68 81 - 82 76 - 77 71 - 72 Metres

- Notes:
 1. Service Layer Credits: Source: Esri, DigitalGlobe, GeoEye, Earthstar Geographics, CNES/Airbus DS, USDA, USGS, AEX, Getmapping, Aerogrid, IGN, IGP, swisstopo, and the GIS User Community
 2. Topography generated from LiDAR point data provided by TRCA. LiDAR data acquired in 2015.
 3. Elevations are in masl.

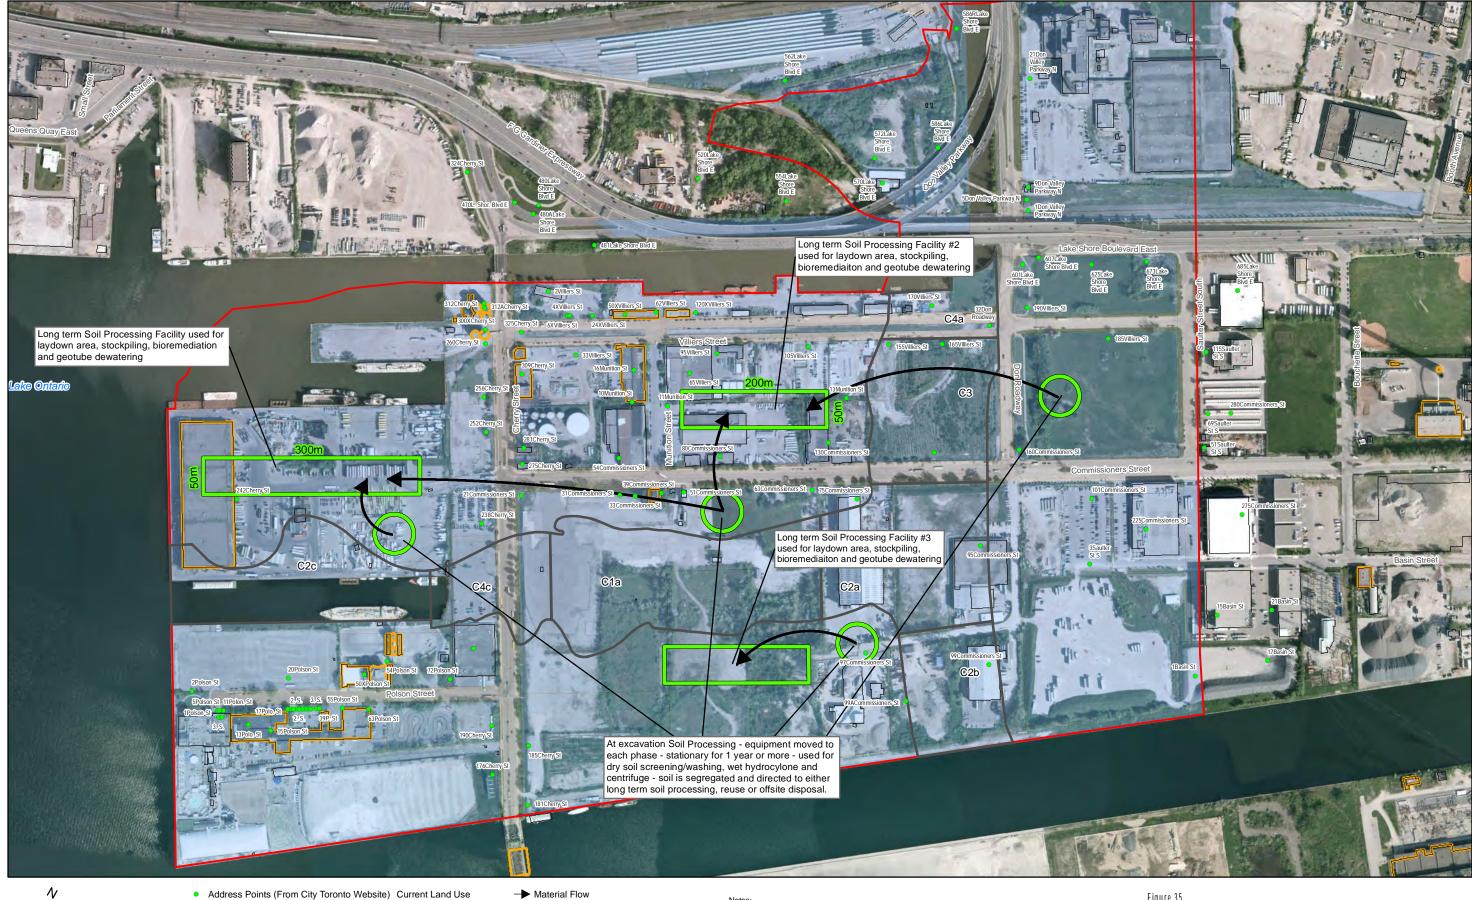
Figure 35
Soil Processing Locations Environmental Assessment and Geotechnical and Earthworks Report Waterfront Toronto Toronto, Ontario

Soil Processing Location Industrial/Commerical Extent of River Valley Excavation Area
